APPENDIX 3.3

Historic Resource Inventory and Evaluation for the San Diego State University Plaza Linda Verde Project, San Diego, California

Stephen Van Wormer, M.A.

July 2009

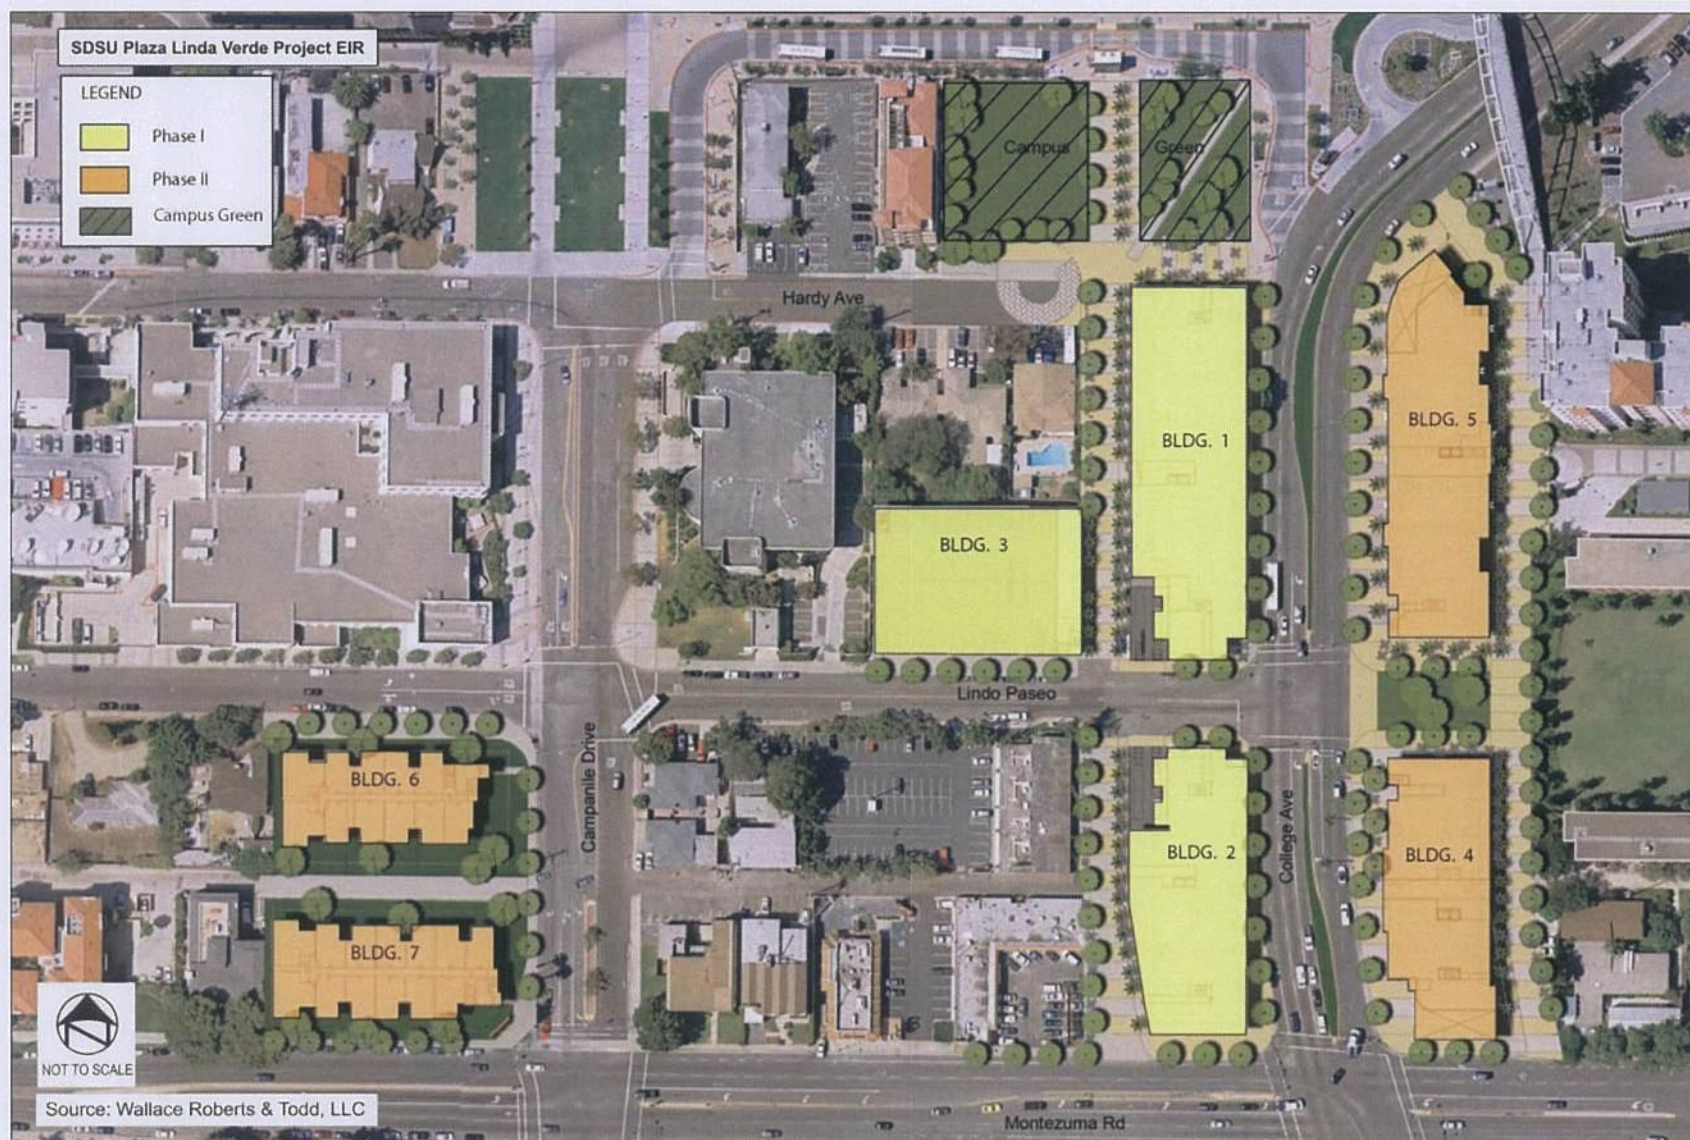
Figure 3. Proposed site plan.

The Proposed Project would consist of development of the following five project components (Figure 3):

IV. Campus Green. A Campus Green is planned for development south of the existing SDSU Transit Center and would consist of active and passive recreational areas for public use.

V. Pedestrian Malls. The Proposed Project also would include two pedestrian malls, in place of existing streets/alleys, to be located along the western and eastern flanks of the main mixed-use building area. These corridors would facilitate non-motorized movement between the proposed buildings and main campus and would support meeting/resting space and outdoor eating facilities associated with the adjacent retail shops. This project component would be ancillary to the Mixed-Use Retail/Student Housing component and would not be essential to development of the overall project site.

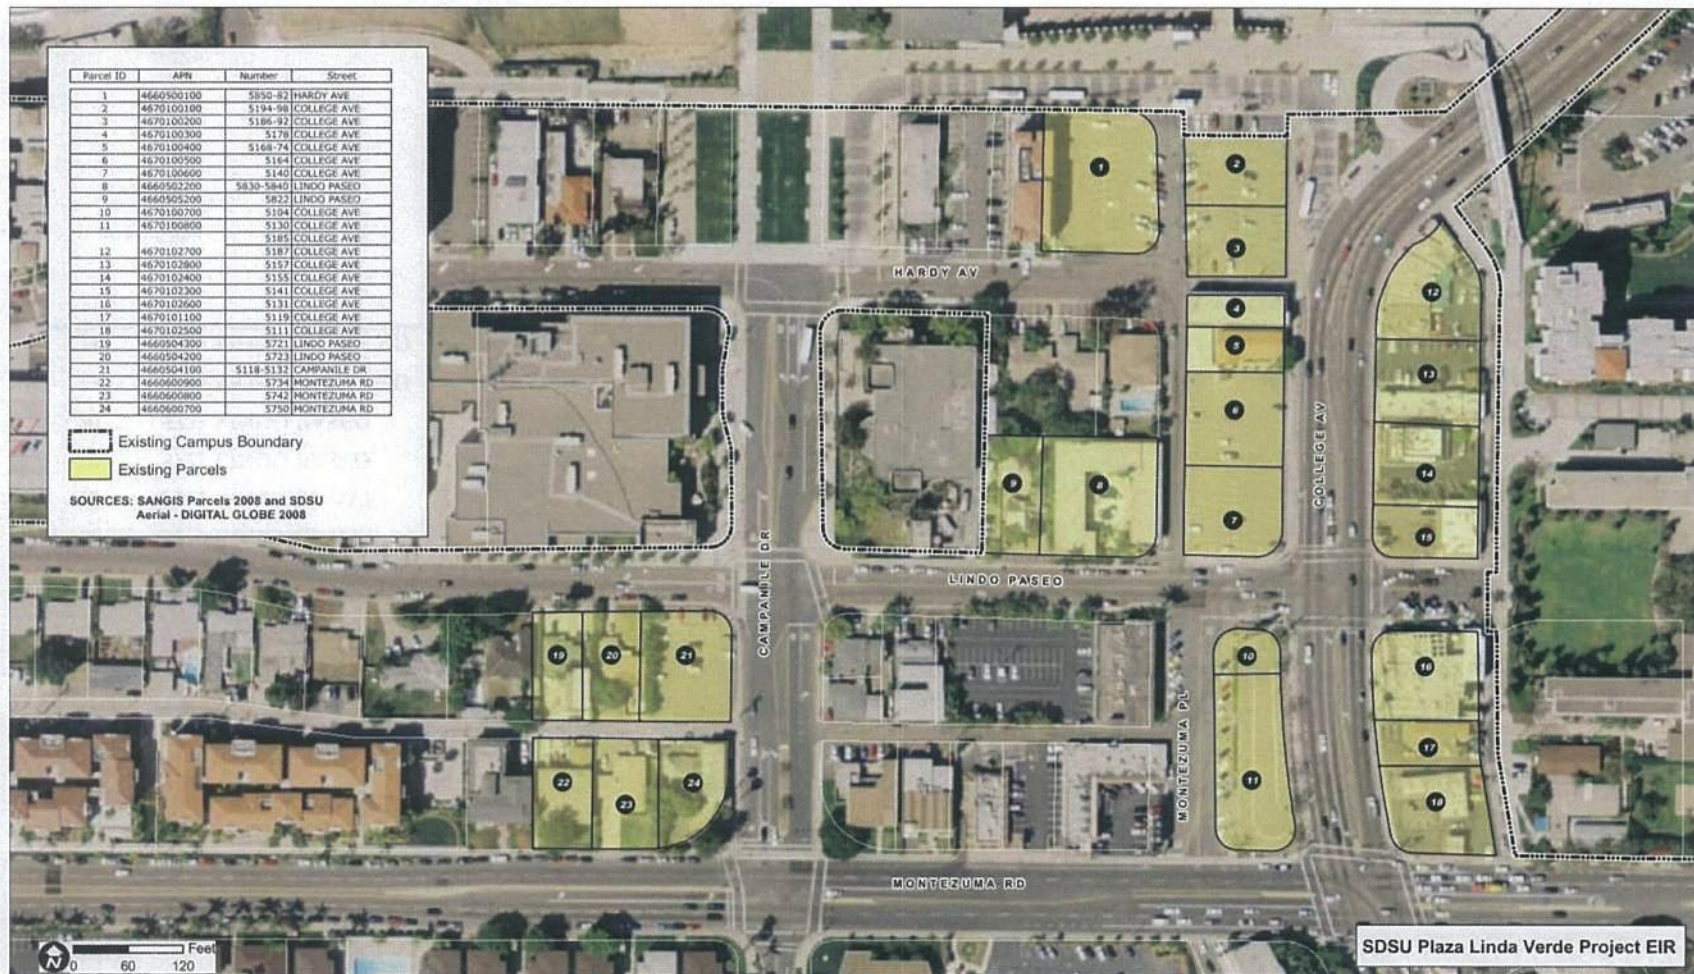
Figure 4. Aerial view showing location of parcels and buildings.

Mr. Stephen Van Wormer, M.A., conducted an inspection of buildings within the SDSU Plaza Linda Verde project area on March 10, 2009. Mr. Van Wormer photographed each of the buildings and documented architectural features and degree of integrity. This inventory was completed from the street as access was not available to many of the parcels for a more detailed inspection. The location of the buildings is shown in Figure 4; Table 1 provides details on each of the buildings.

Figure 4 ID Number	ADDRESS	YEAR BUILT	STYLE	SOURCE OF CONSTRUCTION DATE
4	5178 COLLEGE AVE.	1980s	Modern Commercial	ESTIMATE
5	5168 COLLEGE AVE.	1948	Mediterranean Style Apartment Building	PIERSON 2007
8	5830 LINDO PASEO	1950-55	Modern Apartment Building	PIERSON 2007; CITY DIRECTORIES 1950 - 1955
9	5822 LINDO PASEO	1937	Tudor Style Single Family Dwelling	PIERSON 2007
12	5185 (5158) COLLEGE AVE	1969	Modern Commercial	County Assessor records per Realquest.com
13	5157 COLLEGE AVE	1958	1950s Commercial	County Assessor records per Realquest.com
14	5155 COLLEGE AVE	1965	Modern Commercial Fast Food (Jack in the Box)	County Assessor records per Realquest.com
15	5141 COLLEGE AVE.	1963	Modern Commercial Convenience Store (7/11)	County Assessor records per Realquest.com
16	5131 COLLEGE AVE	1991	Modern Commercial	County Assessor records per Realquest.com
17	5119 COLLEGE AVE	1940-45	Single Family Tract House Converted to Commercial Use	City Directories 1940-1960

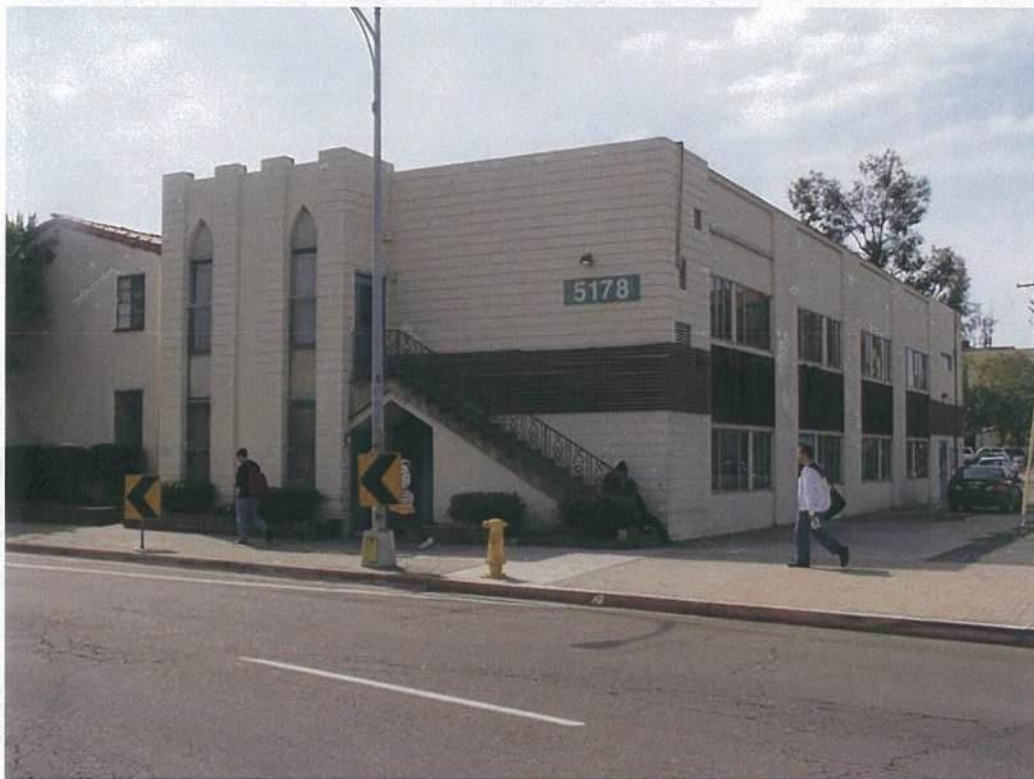
Figure 5. 5178 College Avenue, view of front façade.

This two story, rectangular, modern commercial building has a flat roof (Figure 5). Parallel rows of sliding windows on the first and second floors are located on the north façade. A single entry door on the ground floor and staircase to a similar door on the second floor provide access to the east side. A three-car garage is located behind the building. It is estimated that this building was constructed in the 1980s.

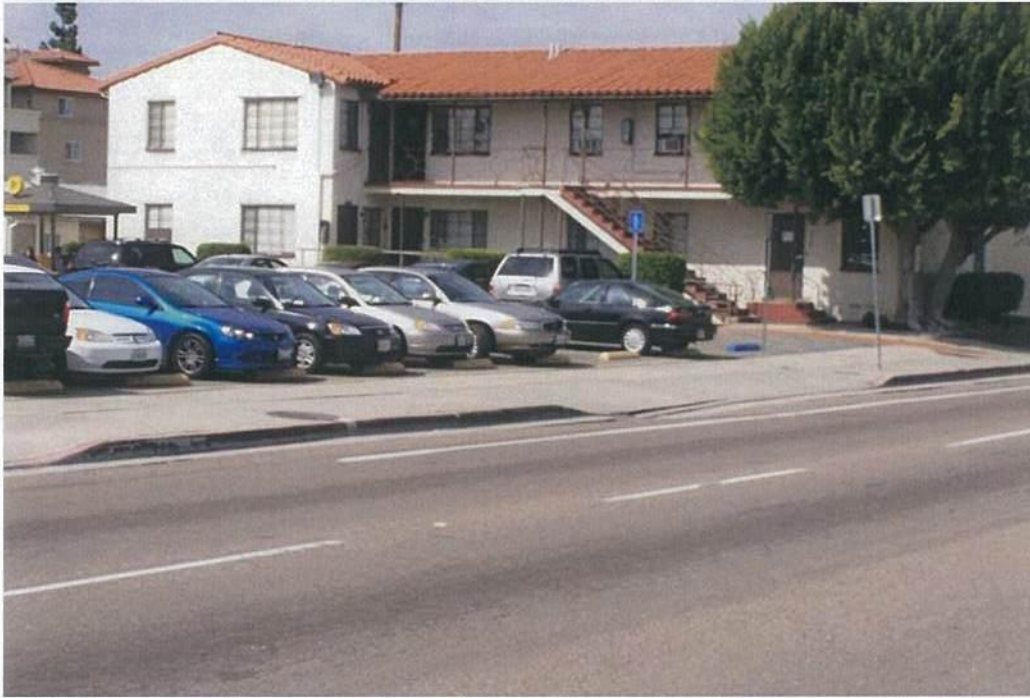
Figure 6. 5168 College Avenue.

This two story, stuccoed, Mediterranean style, “L”-shaped apartment building has a Spanish tile roof (Figure 6). The second story apartments are accessed by a stairway and porch on the south side of the building. Wood framed multi-light windows and single entry doors are placed around the building. The history of the building was documented by Pierson in 2007. It was built in 1948. None of the previous owners or residents were historically significant (Pierson 2007).

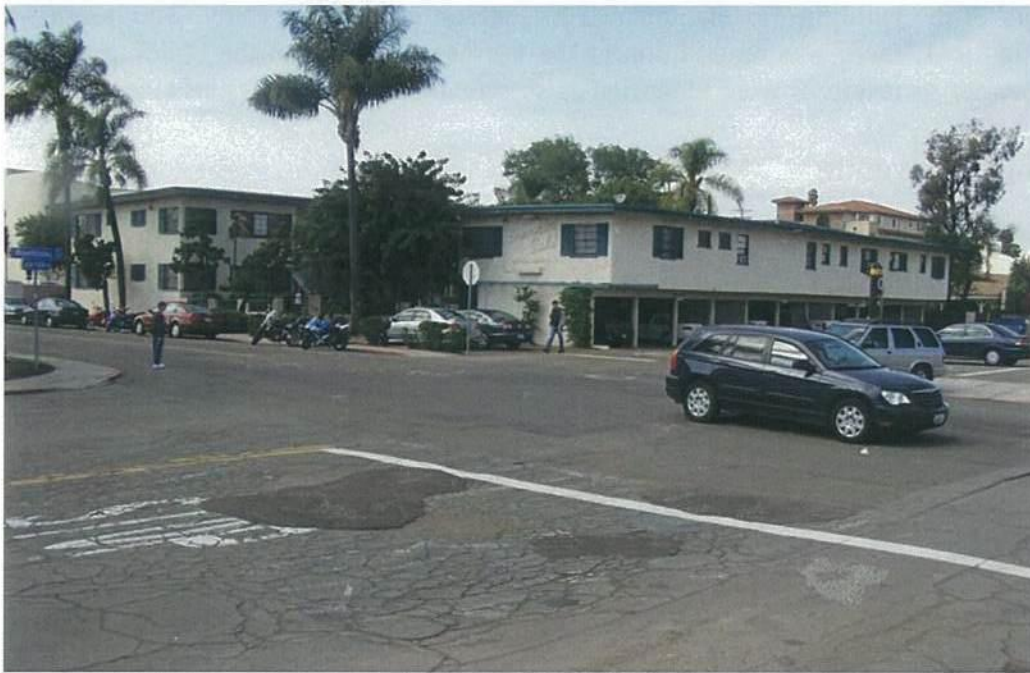
Figure 7. 5830 Lindo Paseo.

This two story, stuccoed, “U”-shaped apartment building is built around a courtyard with a pool (Figure 7). Parking garages are located under the second story of the east wing. The complex has wooden double hung sash windows and an overhanging flat rock covered roof. Concrete stairs with steel railings provide access to the second story. Based on address listings in the city directories the complex was built sometime between 1950 and 1955 (City Directories 1940–1960).

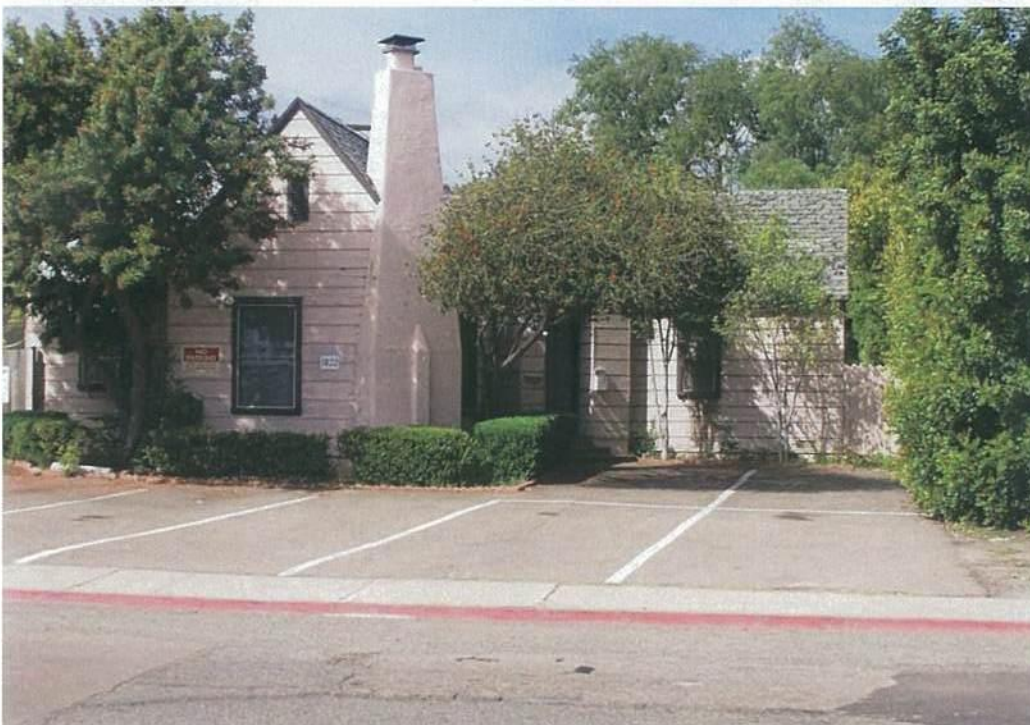
Figure 8. 5822 Lindo Paseo.

This “L”-shaped Tudor style house has a steeply pitched roof covered with diamond patterned asphalt shingles (Figure 8). The sides of the house are covered with horizontal wooden siding. A stuccoed chimney is located at the southeast corner of the west wing. Wood framed double hung sash windows are irregularly placed along all sides and the main entrance is located on the front of the house at the corner of the inside intersection of the “L”-shaped footprint.

The history of the building was documented by Pierson in his 2007 study. The house was built in 1937. In 1944, there was an addition to the northeast portion of the building. None of the previous owner or residents were identified as significant historical persons (Pierson 2007).

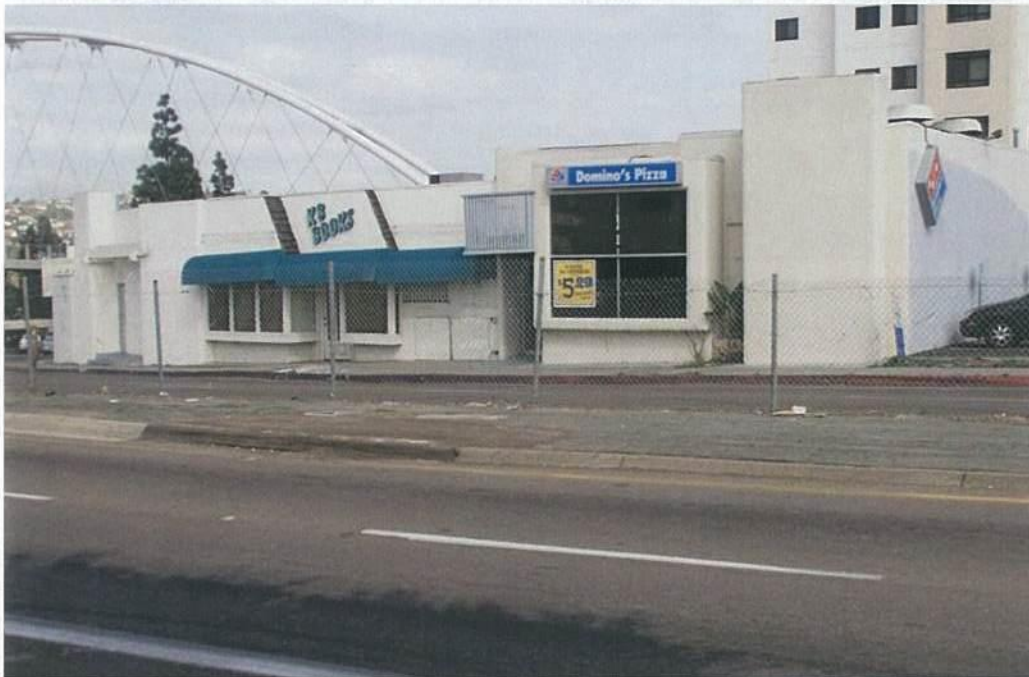
Figure 9. 5185 College Avenue.

This is a single story, irregularly shaped, stucco covered, modern commercial structure with a flat roof and modern commercial plate glass windows in a variety of shapes and sizes (Figure 9). Property records indicate it was originally built in 1969 (Realquest 2009). It has apparently undergone a number of modifications since that time. Its current style represents construction closer to a 1980 to 1990 time period.

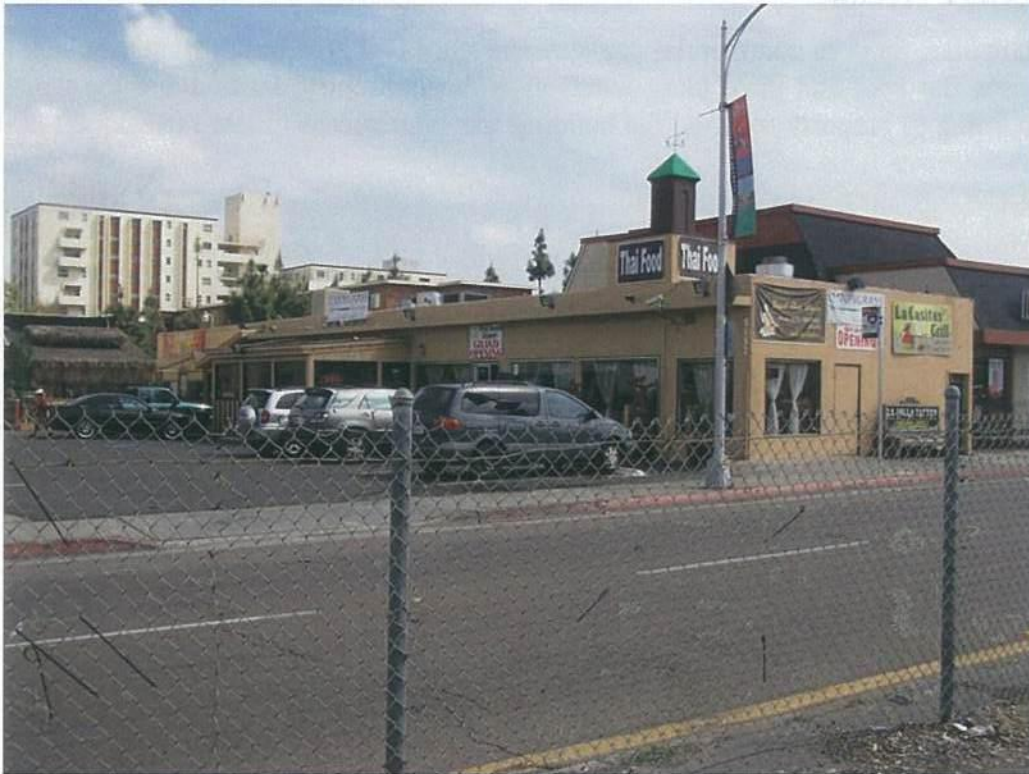
Figure 10. 5157 College Avenue.

This single story, stucco covered, “L”-shaped 1950s commercial building has a flat roof (Figure 10). Plate glass windows and commercial entry doors are located along the north façade. The building was constructed in 1958 (Realquest 2009).

***P3a. Description:** (Describe resource and its major elements. Include design, materials, condition, alterations, size, setting, and boundaries)
 This single story, stucco covered, "L"-shaped 1950s commercial building has a flat roof. Plate glass windows and commercial entry doors are located along the north façade. The building was constructed in 1958.

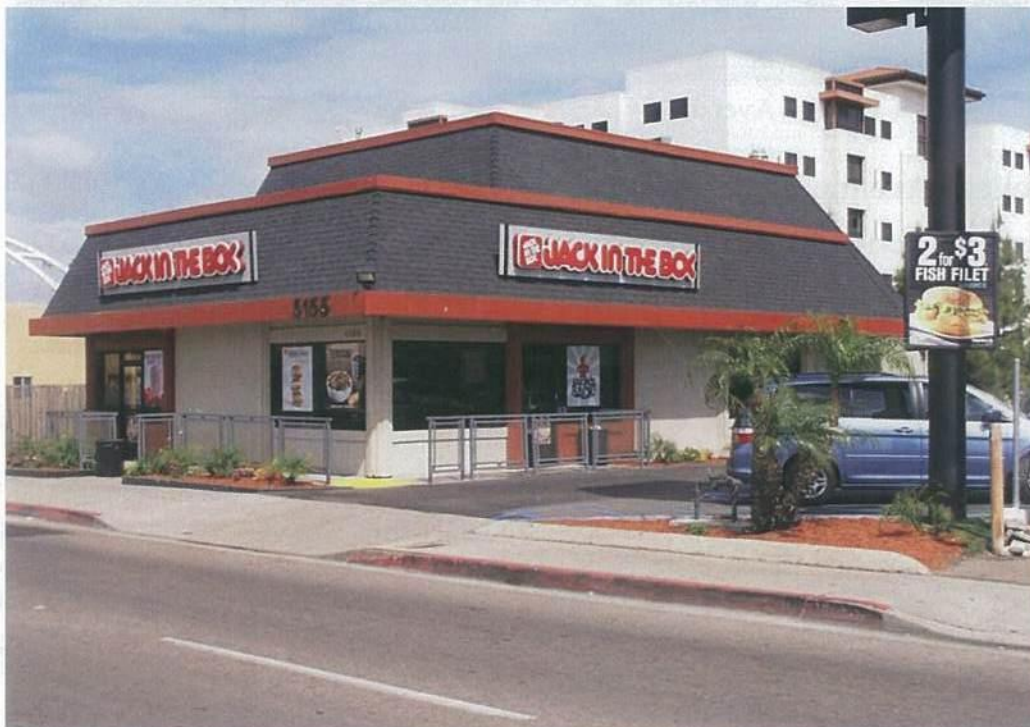
Figure 11. 5155 College Avenue.

This two story, modern commercial modern fast food restaurant (Jack in the Box) is an irregular rectangle in shape. It has plate glass windows and is covered with stucco. The flat roof has asphalt shingle-covered hipped parapets along all four sides. According to property records, the building was originally constructed in 1965 (Realquest 2009). It appears to have been remodeled and its current appearance represents construction circa 1980 to 2000 (Figure 11).

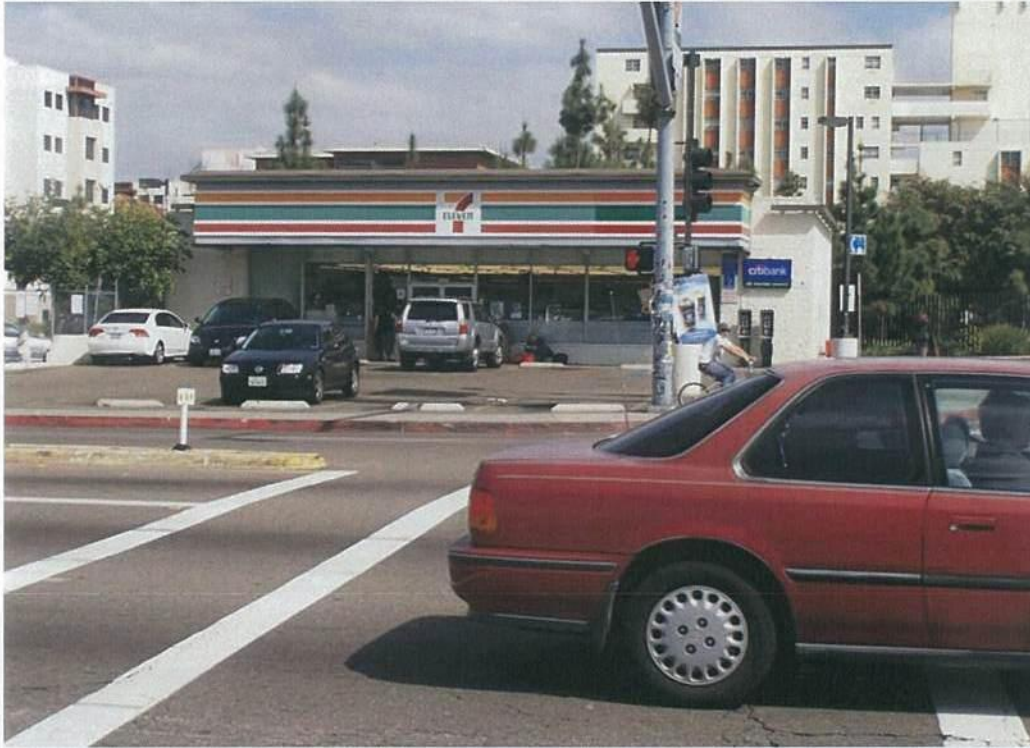
Figure 12. 5141 College Avenue.

This rectangular, modern commercial convenience store (7/11) is built of cinder block (Figure 12). It has a flat roof and plate glass windows with glass entry doors along the front (west) side. According to property records, the building was constructed in 1963 (Realquest 2009).

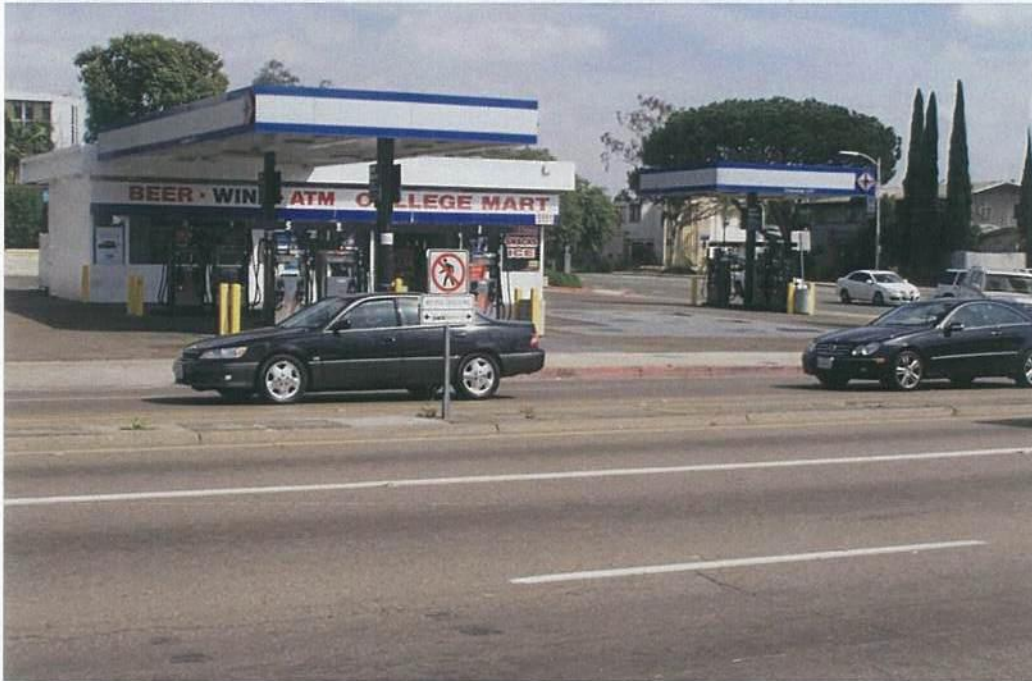
Figure 15. 5111 College Avenue.

This modern gas station consists of a single story, rectangular, stucco covered building with rows of plate glass windows (Figure 15). Formerly a garage and office, it has been converted to a convenience store. Large awnings directly in front (west) of the store and on the south side shelter gas pumps. According to property records, the building was constructed in 1955 (Realquest 2009).

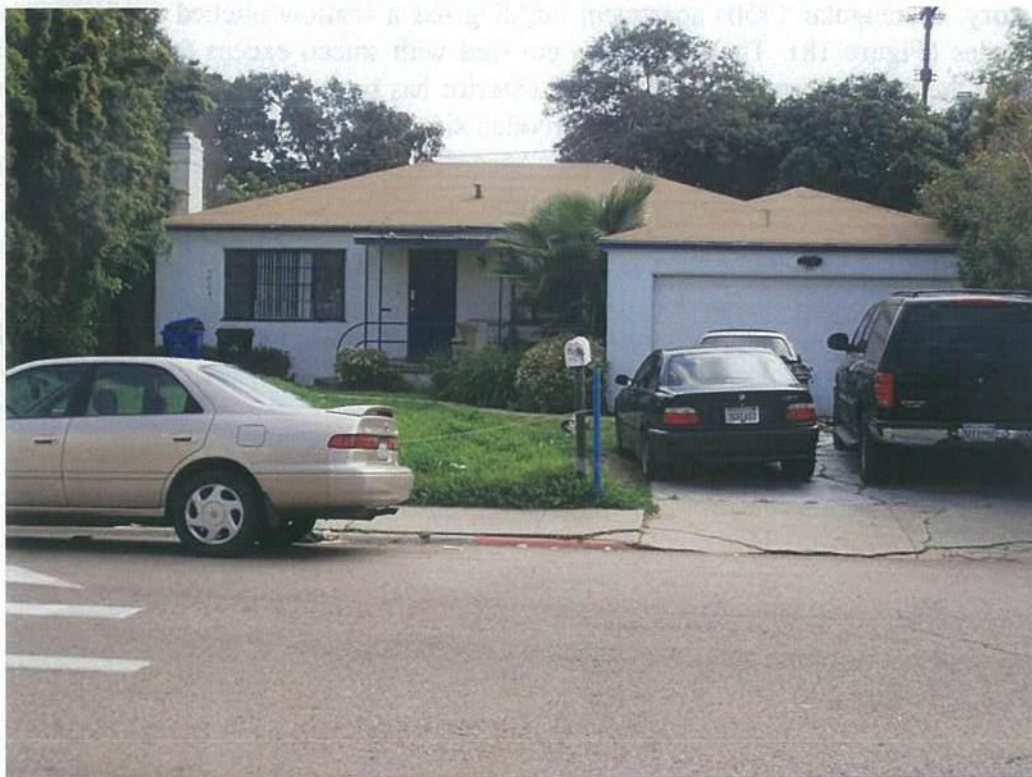
Figure 17. 5723 Lindo Paseo.

This rectangular, stucco covered, single family dwelling has a complex hip roof covered with asphalt shingles (Figure 17). An attached garage is located at the northwest corner. The building exhibits wooden double hung sash, and aluminum framed sliding windows. A two story addition has been added to the rear of the building. The house was constructed in 1940 (Pierson 2007).

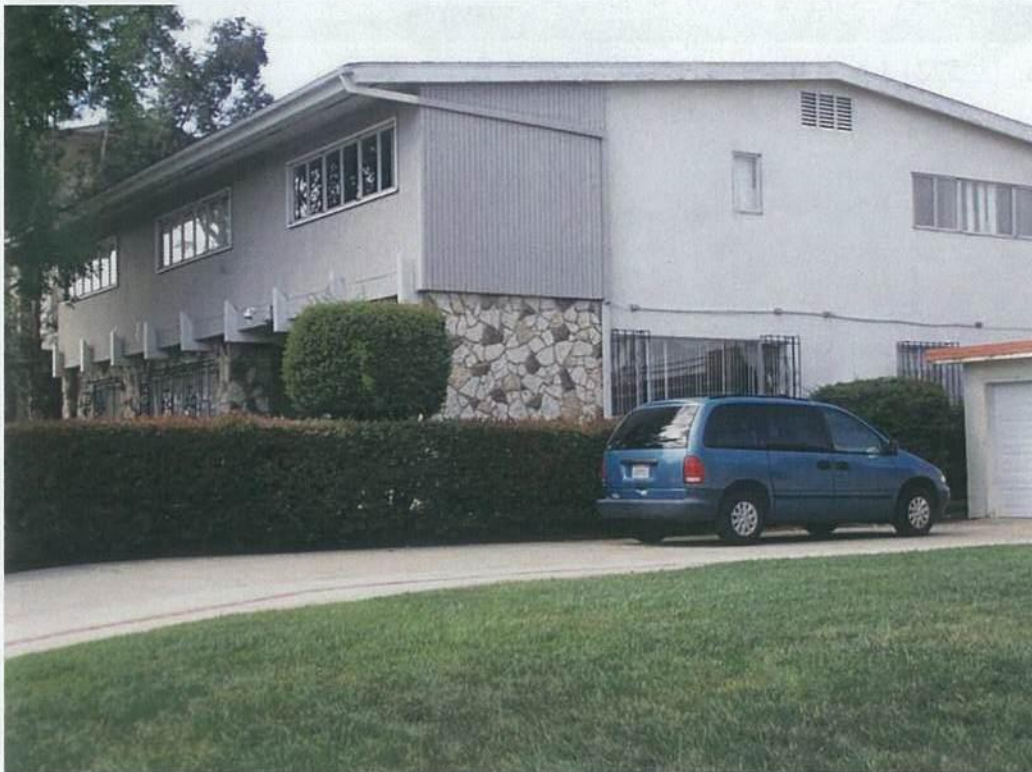
Figure 19. 5742 Montezuma Road.

This very simple, rectangular shaped, postmodern style tract house has a flat roof covered with red rock (Figure 19). The roof on a detached garage at the west end of the house is of the same design and material. The building is covered with stucco and has rows of plate glass windows just below the roof line. It was built in 1945 (Realquest 2009).

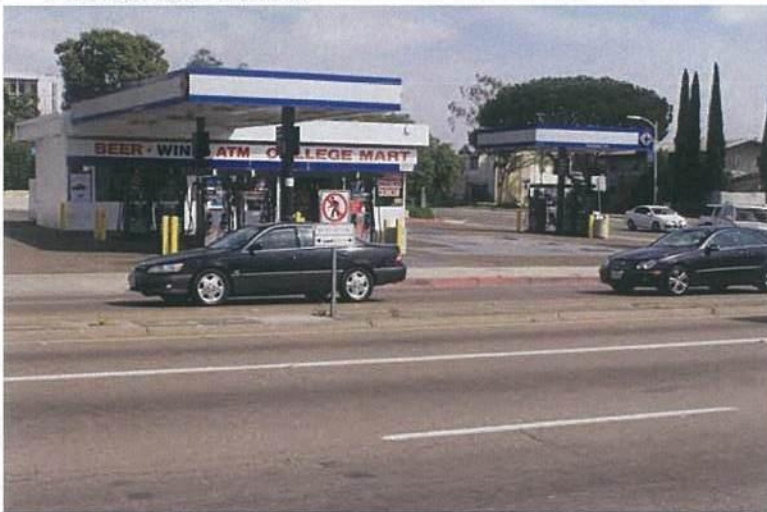
*P3a. Description: (Describe resource and its major elements. Include design, materials, condition, alterations, size, setting, and boundaries)
This modern gas station consists of a single story, rectangular, stucco covered building with rows of plate glass windows. Formerly a garage and office, it has been converted to a convenience store. Large awnings directly in front (west) of the store and on the south side shelter gas pumps. According to property records, the building was constructed in 1955.

P5b. Description of Photo: (View, date, accession #)
View of 5111 College Avenue, facing southeast, 3-10-2009.

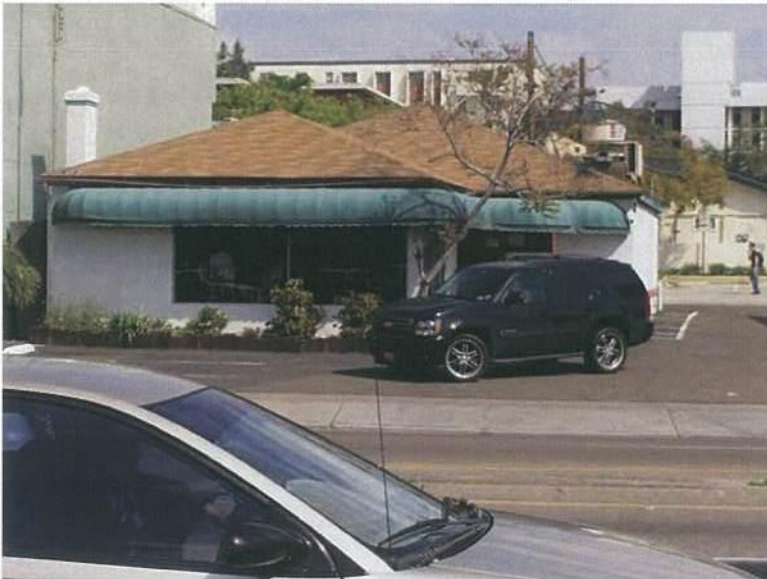
***P3a. Description:** (Describe resource and its major elements. Include design, materials, condition, alterations, size, setting, and boundaries)
 This single story, late 1940s, single family residence has been converted to commercial use. It retains its original "L"-shaped footprint, and moderately sloped, asphalt shingle-covered hipped roof. Large plate glass windows have replaced original windows on the front (west) façade. Commercial awnings have also been added along this side of the building. Based on address listings in city directories, the house appears to have been built between 1940 and 1945.

P5b. Description of Photo: (View, date, accession #)
 View of 5119 College Avenue, facing east, 3-10-2009.

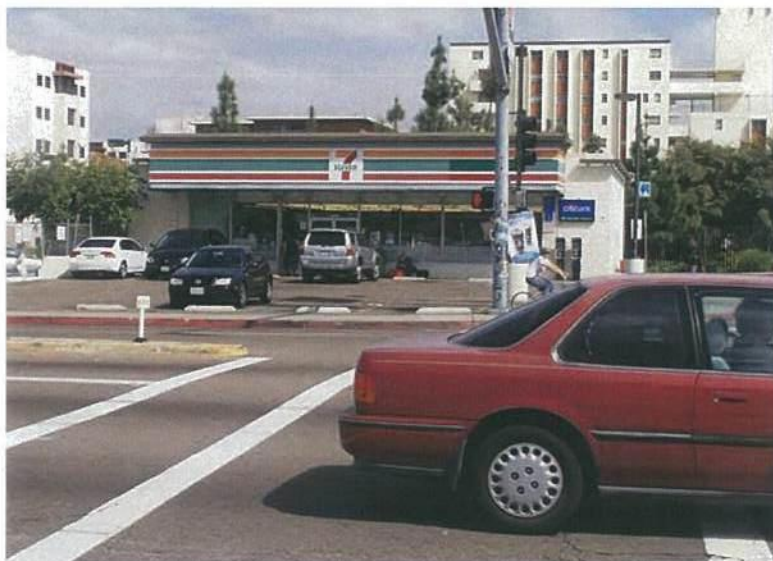
*P3a. Description: (Describe resource and its major elements. Include design, materials, condition, alterations, size, setting, and boundaries)
This rectangular, modern commercial convenience store (7/11) is built of cinder block. It has a flat roof and plate glass windows with glass entry doors along the front (west) side. According to property records, the building was constructed in 1963.

P5b. Description of Photo: (View, date, accession #)
View of 5141 College Avenue, facing east, 3-10-2009.

5141 College Avenue fails to meet the age threshold for the eligibility requirement for inclusion in the NRHP or the CRHR. Also, the building does not appear to meet any of the first three criterion for listing on the NRHP or the CRHR, and therefore, is determined to be not eligible for these Registers due to its lack of historical and architectural significance and poor integrity.

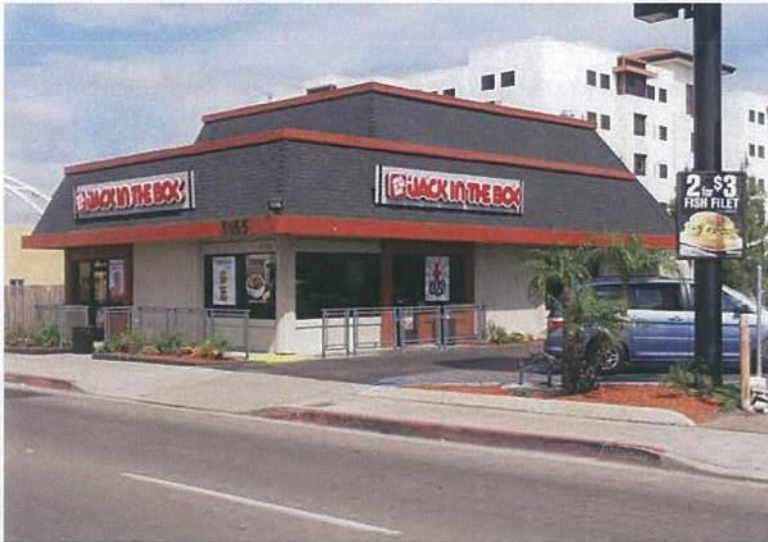
*P3a. Description: (Describe resource and its major elements. Include design, materials, condition, alterations, size, setting, and boundaries)
This two story, modern commercial modern fast food restaurant (Jack in the Box) is an irregular rectangle in shape. It has plate glass windows and is covered with stucco. The flat roof has asphalt shingle-covered hipped parapets along all four sides. According to property records, the building was originally constructed in 1965. It appears to have been remodeled and its current appearance represents construction circa 1980 to 2000.

P5b. Description of Photo: (View, date, accession #)
View of 5155 College Avenue, facing northeast, 3-10-2009.

5155 College Avenue fails to meet the age threshold for the eligibility requirement for inclusion in the NRHP or the CRHR. Also, the building does not appear to meet any of the first three criterion for listing on the NRHP or the CRHR, and therefore, is determined to be not eligible for these Registers due to its lack of historical and architectural significance and poor integrity.

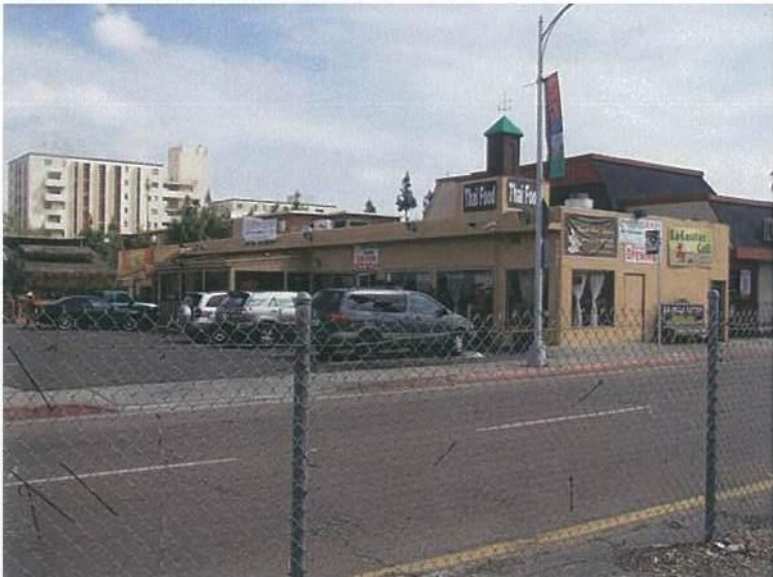
P5b. Description of Photo: (View, date, accession #)
 View of 5751 College Avenue, facing southeast, 3-10-2009.

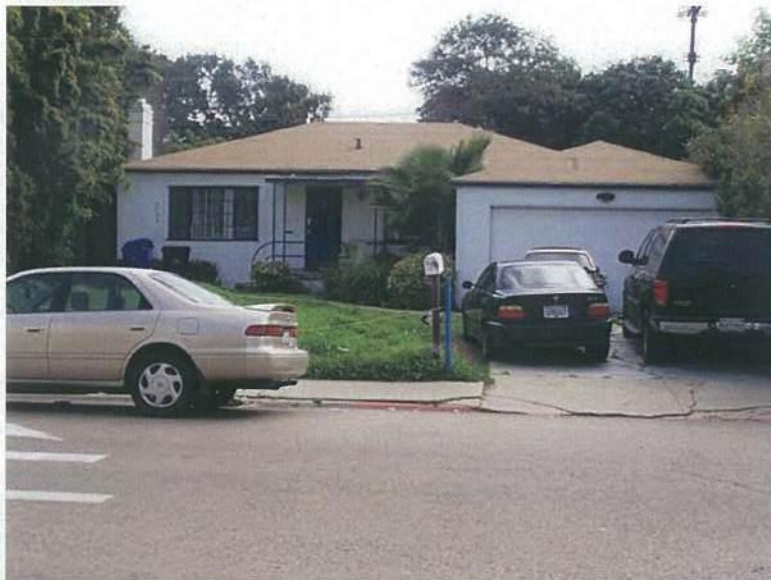
***P3a. Description:** (Describe resource and its major elements. Include design, materials, condition, alterations, size, setting, and boundaries)
This rectangular, stucco covered 1940s tract house has a hipped roof with asphalt shingles. A garage is located on the front (north) side of the house. Fixed metal frame casement windows are located on the front side. Steps and a small porch on this face lead to a single entry door that provides access to the interior. A chimney is located on the north side of the building. The building was constructed in 1941.

P5b. Description of Photo: (View, date, accession #)
View of 5721 Lindo Paseo, facing south, 3-10-2009.

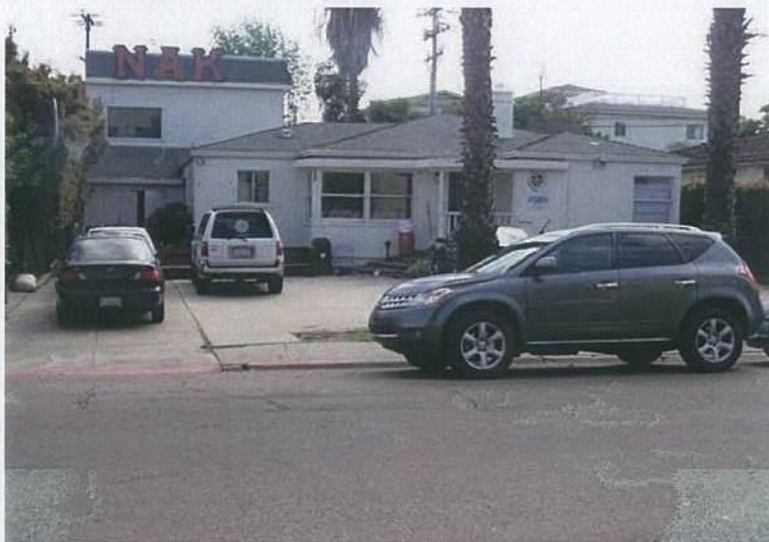
*P3a. Description: (Describe resource and its major elements. Include design, materials, condition, alterations, size, setting, and boundaries)
This rectangular, stucco covered, single-family dwelling has a complex hip roof covered with asphalt shingles. An attached garage is located at the northwest corner. The building exhibits wooden double hung sash, and aluminum framed sliding windows. A two-story addition has been added to the rear of the building. The house was constructed in 1940.

P5b. Description of Photo: (View, date, accession #)
View of 5723 Lindo Paseo, facing south, 3-10-2009.

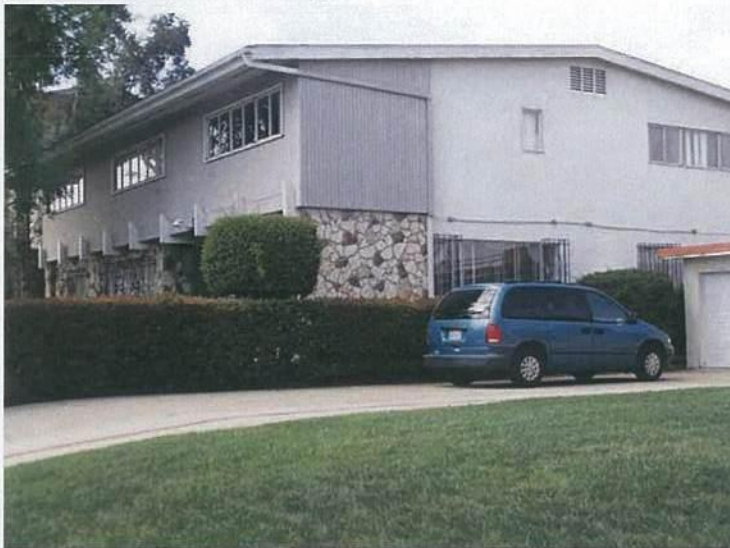
P5b. Description of Photo: (View, date, accession #)

View of 5734 Montezuma Road, facing north, 3-10-2009.

This two story, rectangular 1950s apartment building has a shallow pitched roof covered with asphalt shingles (Figure 18). The building is covered with stucco except for the front (south) portion facing the street. Here the bottom floor exterior has been treated with flagstone and the upper floor is covered with a vertical placed wooden siding. Rows of aluminum framed sliding windows are located throughout the building. According to property records, the apartment complex was constructed in 1955 (Realquest 2009).

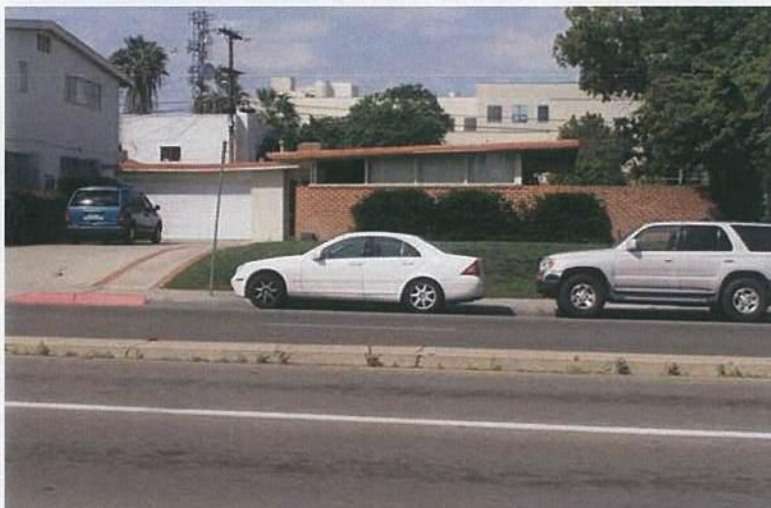
*P3a. Description: (Describe resource and its major elements. Include design, materials, condition, alterations, size, setting, and boundaries)
This very simple, rectangular shaped, postmodern style tract house has a flat roof covered with red rock. The roof on a detached garage at the west end of the house is of the same design and material. The building is covered with stucco and has rows of plate glass windows just below the roofline. It was built in 1945.

P5b. Description of Photo: (View, date, accession #)
View of 5742 Montezuma Road, facing north, 3-10-2009.

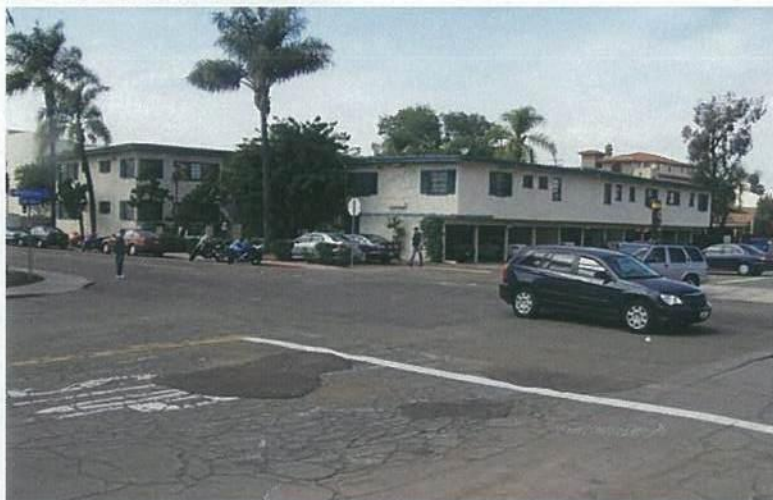
*P3a. Description: (Describe resource and its major elements. Include design, materials, condition, alterations, size, setting, and boundaries)
This two story, stuccoed, "U"-shaped apartment building is built around a courtyard with a pool. Parking garages are located under the second story of the east wing. The complex has wooden double hung sash windows and an overhanging flat rock covered roof. Concrete stairs with steel railings provide access to the second story. Based on address listings in the city directories the complex was built sometime between 1950 and 1955 (City Directories 1940-1960).

P5b. Description of Photo: (View, date, accession #)
View of 5830 Lindo Paseo, facing northwest, 3-10-2009.
