**SECTION 3.5**  
**GEOTECHNICAL/SOILS**

This section is based on a geotechnical impact report prepared for the proposed project by Southland Geotechnical Consultants (May 2007). The Geotechnical Report evaluated existing geotechnical conditions (*e.g.*, geologic hazards, soil engineering properties, and onsite pedologic characteristics) and identified potential geotechnical constraints to the proposed project. The technical report is presented in its entirety in **Appendix F** of this EIR.

San Diego State University  
 2007 Campus Master Plan Revision

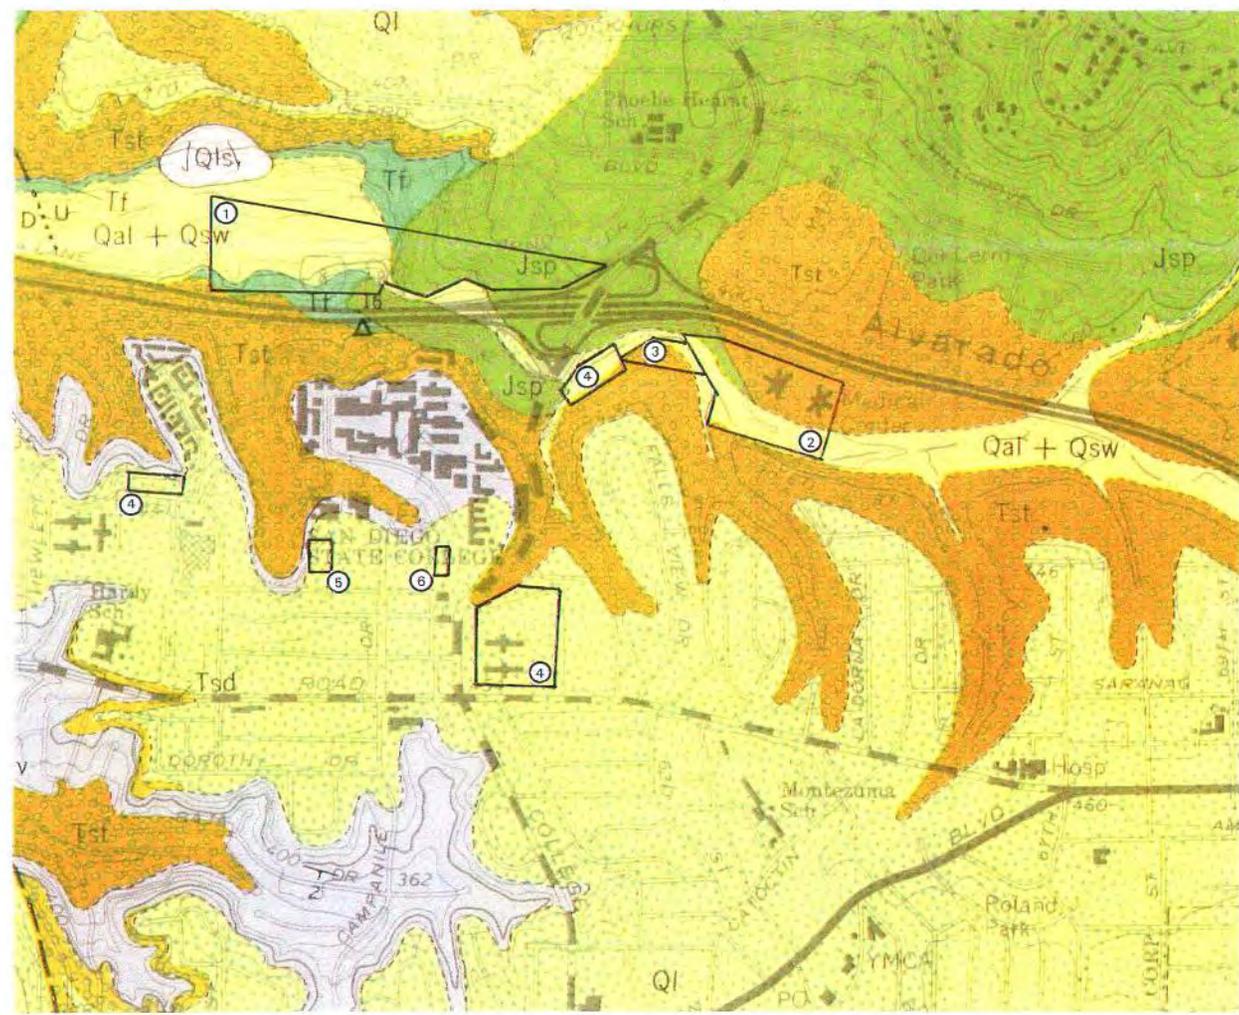
Project No. 270C111      FIGURE 1

Contact <i>(dashed where approximately located; dotted where concealed)</i>
	Fault, showing dip <i>(dashed where approximately located; dotted where concealed; U, upthrown; D, downthrown side)</i>

- Approximated Locations of Project Components:
- ① Adobe Falls
  - ② Alvarado Campus
  - ③ Alvarado Hotel
  - ④ Student Housing
  - ⑤ Campus Conference Center
  - ⑥ Aztec Center

GENERALIZED GEOLOGIC MAP

GEOLOGIC UNITS (see Figure 1)	Adobe Falls	Alvarado Campus	Student Union	Student Housing	Alvarado Hotel	Campus Conference Center
		fill soils alluvium/slopewash Stadium Conglomerate Friars Formation Santiago Peak Volcanics	fill soils alluvium/slopewash Stadium Conglomerate Santiago Peak Volcanics	fill soils, Lindavista Formation	fill soils Lindavista Formation Mission Valley Formation Stadium Conglomerate Santiago Peak Volcanics	fill soils alluvium/slopewash Stadium Conglomerate Santiago Peak Volcanics
<b>GEOLOGIC/SOIL RESOURCES</b>						
USDA Soil Survey	Rm, FxE, Ohe	TuB, FxE, DcF	OkC	OkC, RhC, FxE	FxE	OkC
CDMG Mineral Resource Zone	MRZ-3	MRZ-2	MRZ-2	MRZ-2/3	MRZ-2/3	MRZ-2
<b>POTENTIAL GEOTECHNICAL CONSTRAINTS</b>						
Landslides/ Slope Instability	X	X	---	X	X	---
Erosion	X	X	X	X	X	X
Unconsolidated Soils	X	X	X	X	X	X
Expansive Soils	X	X	X	X	X	X
Hard Rock/ Excavatability	X	X	X	X	X	X
Groundwater/ Seepage	X	X	X	X	X	X

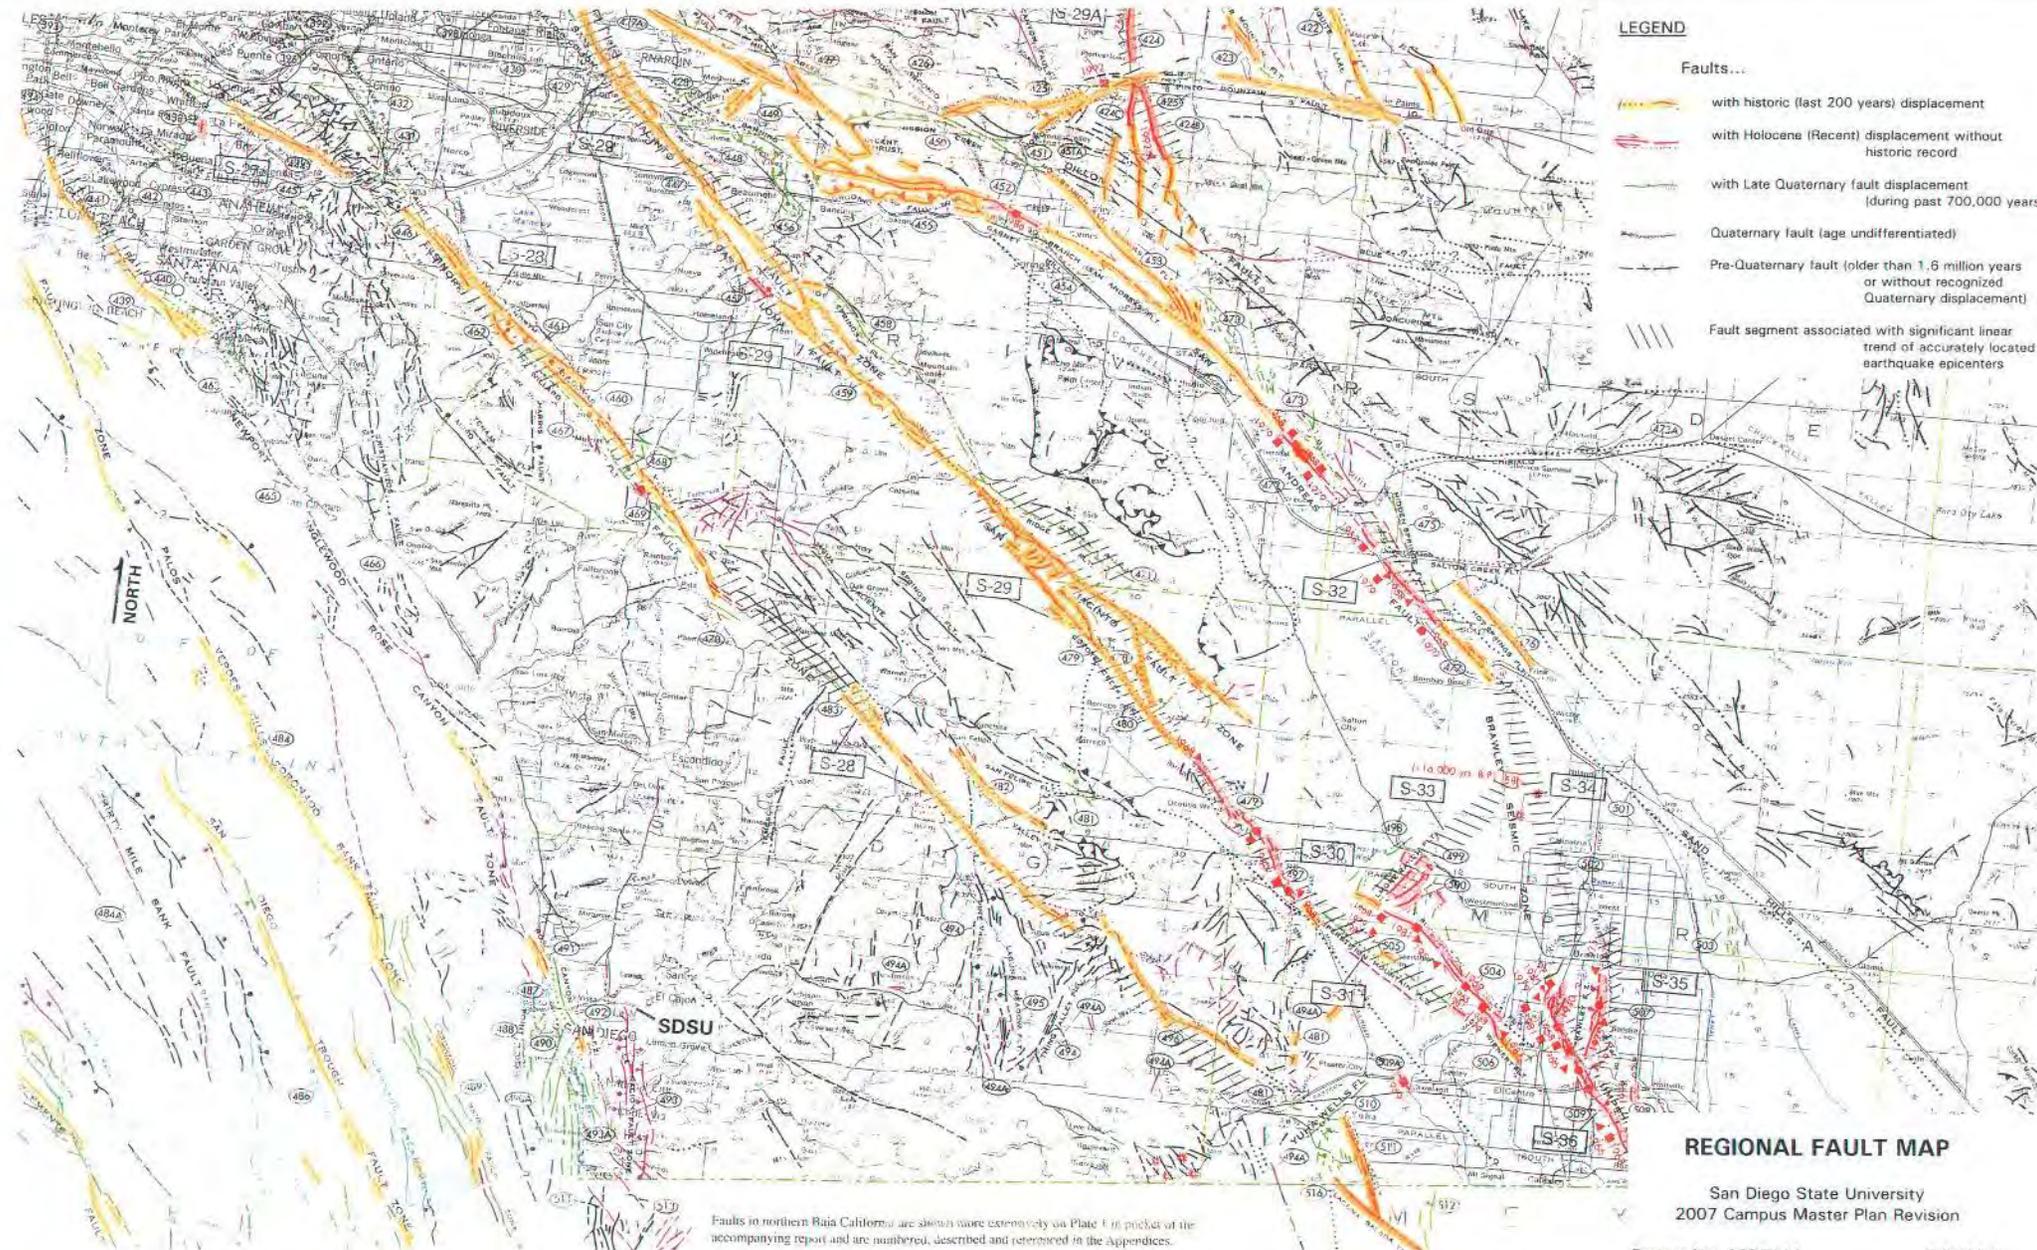
Faults in northern Baja California are shown more extensively on Plate 1 in product of the accompanying report and are numbered, described and referenced in the appendices.

Based on a review of the City of San Diego's Seismic Safety Study, the SDSU campus is located approximately 0.3 mile east-northeasterly of a mapped trace of the La Nacion fault. The La Nacion fault generally is not known to displace Quaternary deposits; therefore, the La Nacion fault currently is interpreted by most geologists not to be an "active" fault based on CGS criteria. Surficial evidence for on-site active faulting was not observed during site visits conducted in connection with the preparation of this analysis.
